Manhole Inspection Summary

Manhole # S37GG1021MH

Insp Date: **1/10/07 4:32 PM**

Location Address: **3983 FRISBY ST**

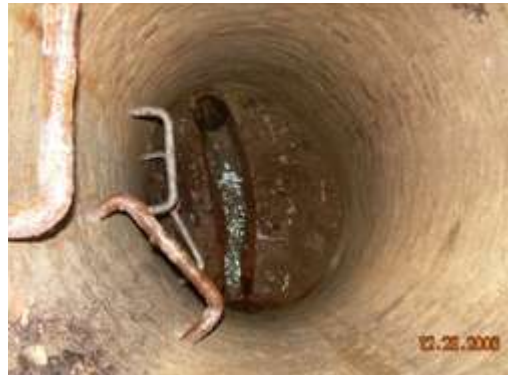
Top View

Bench ☒ Exists Material: **Brick** ☐ Parged ☒ **Debris** (not Condition related)

Steps Count: **6** Missing: **0** ☒ **Corroded**

Corroded steps. Bench debris.

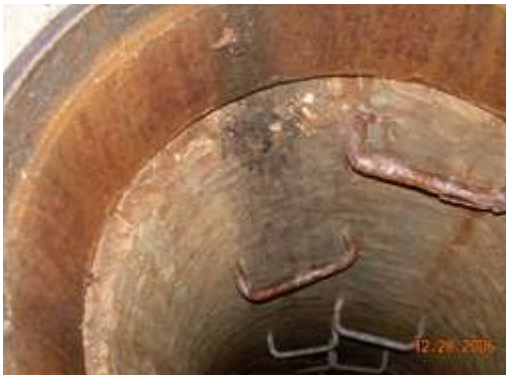
Defect

Frame Offset: **0** (in.) Condition: ☐ Sound ☐ Cracked ☒ **Leaks**

Condition: ☐ Sound ☐ Cracked ☐ Root Intrusion ☐ Loose Brick ☒ **Deteriorated**

Infiltration: ☐ None ☒ **Joint** ☐ Cracks ☐ Mortar ☐ Roots ☒ **Wall**

Infiltration: ☐ None ☐ Joint ☐ Cracks ☐ Mortar ☐ Roots ☒ **Wall**

Frame leaks. Adjustment deterioration and infiltration. Barrel infiltration.

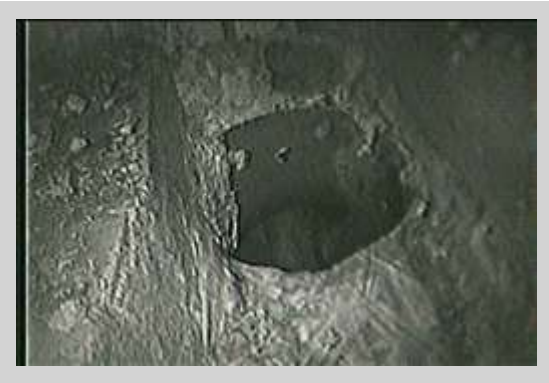
8 in. Circular Gravity Sewer Pipe Out @ 12 O'Clock

Comments **12 OCLOCK PIPE GOES DOWNWARD INTO THE GROUND**

PIPE GOES DOWNWARD INTO THE
GROUND
